POQUONOCK RIVER BASIN
GROTON, CONNECTICUT

POQUONOCK DAM

CT 00231

PHASE I INSPECTION REPORT
NATIONAL DAM INSPECTION PROGRAM

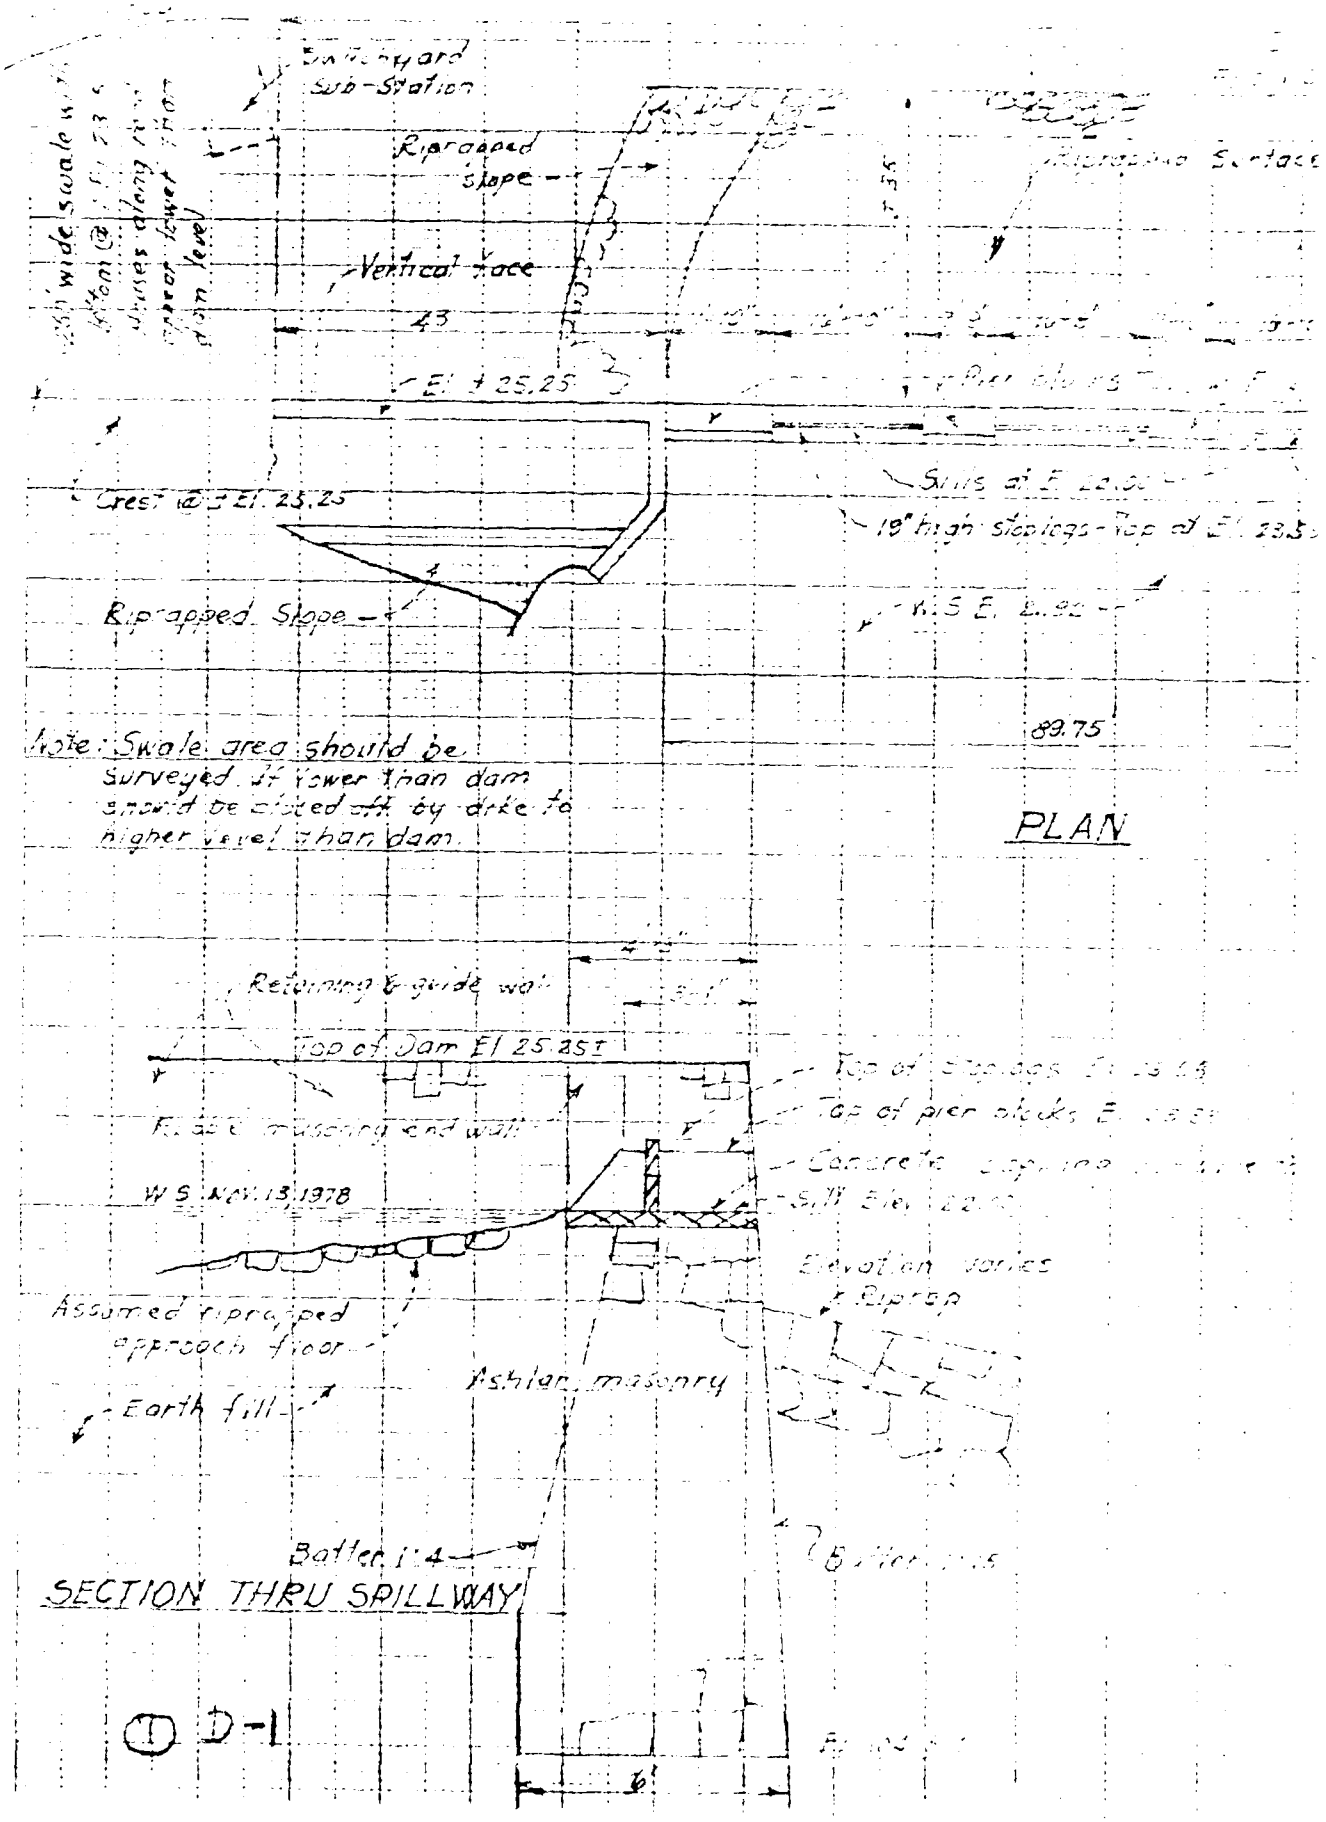
Switchyard
Sub-Station
Riprapped
slope
Vertical face
43
El 425.25
Crest @ El. 425.25
Riprapped Slope
Note: Swale area should be
surveyed. If lower than dam
should be closed off by dike to
higher level than dam.
PLAN
Returning & guide wall
Top of Dam El 425.25
W.S. Nov. 13, 1978
Assumed riprapped
approach floor
Earth fill
Ashlar masonry
Elevation varies
Riprap
Batter 1:4
SECTION THRU SPILLWAY
D-1
